EPA Superfund Record of Decision:

Hanford 100 Area (USDOE), 100-IU-1, 100-IU-3, 100-IU-4 & 100-IU-5 Operable Units, Benton County, WA 2/2/1996

DECLARATION OF THE RECORD OF DECISION

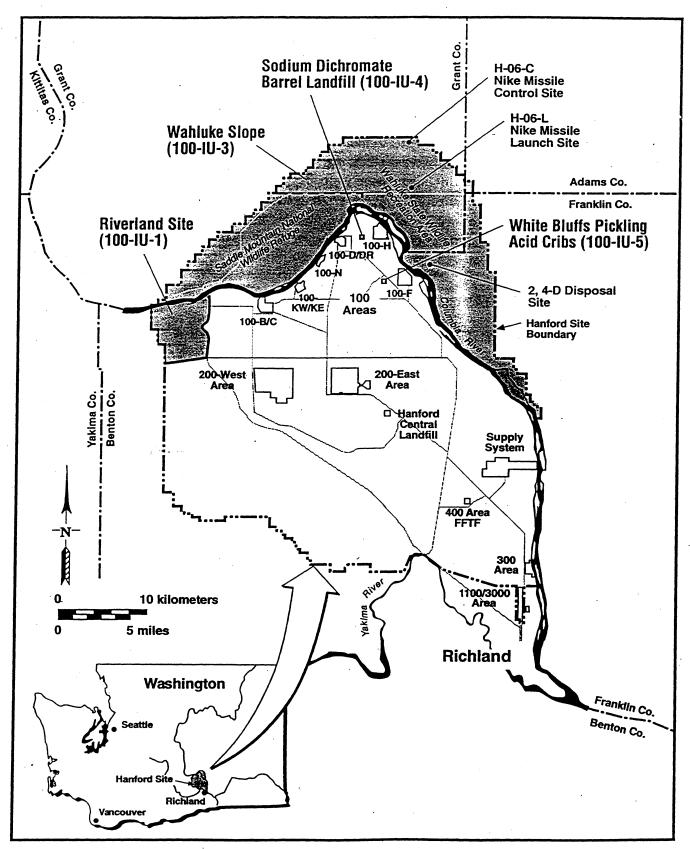
Figure 1. Locations of 100-IU-1, 100-IU-3, 100-IU-4, and 100-IU-5 Operable Units at the Hanford Site.

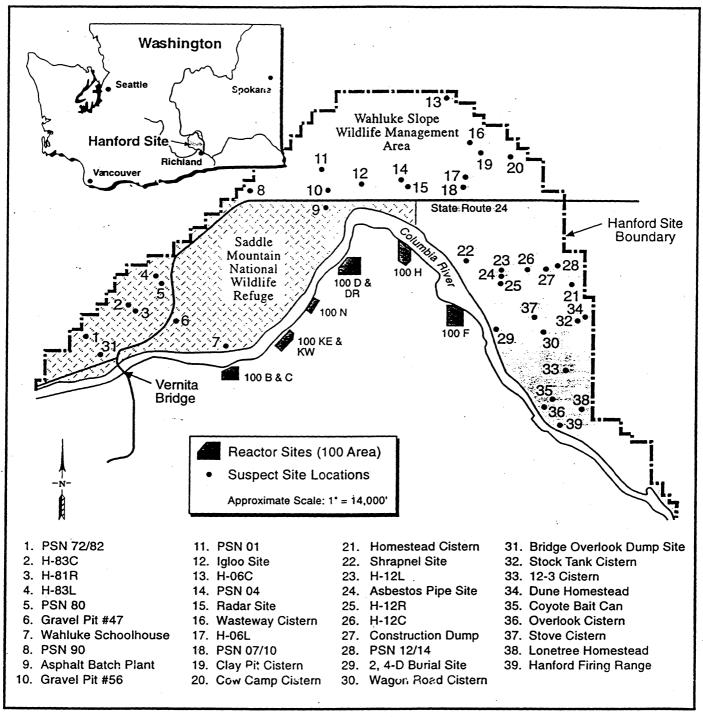
Figure 4. Location of Sites Within the 100-IU-3 Operable Unit (Wahluke Slope).

Ownership of the Wahluke Slope is shared between USDOE and the U.S. Bureau of Land Management. Under an agreement with USDOE, approximately 25% of the Wahluke Slope (Figure 4) is managed as the Saddle Mountain National Wildlife Refuge by the U.S. Fish and Wildlife Service, allowing limited public access. The remaining 75% is permitted to the Washington State Department of Wildlife as the Wahluke Wildlife Recreation Area, and is open to the public during daylight hours. This area was acquired for use as a military buffer zone against potential hostile attacks on the 100 Area reactors. Several Anti-Aircraft Artillery Batteries and three Nike Missile Sites were located on the Wahluke Slope. These sites were decommissioned in 1960-1961, and demolished in 1974. Facilities handling radioactive materials were not built here, and surveys performed revealed only natural background levels.

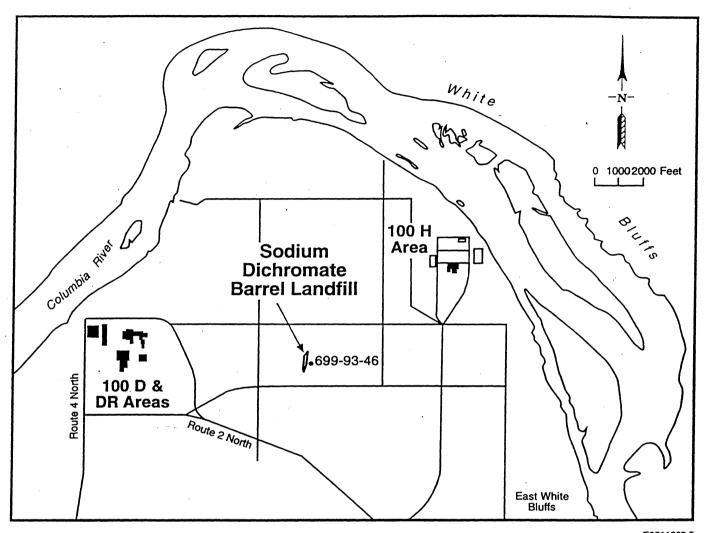
Figure 5. Location of the 100-IU-4 Operable Unit (Sodium Dichromate Barrel Landfill Site).

The Sodium Dichromate Barrel Landfill is the only waste site located within the 100-IU-4 Operable Unit. The landfill is located in a small depression between the 100-D and 100-H Reactor Areas (Figure 5). Little historical documentation of the site is available. The landfill was used during the years of reactor operation for disposal of crushed, empty Sodium Dichromate barrels. Sodium Dichromate was used as a corrosion inhibitor in the reactor cooling water systems of the 100 Area reactors. The site is not known to have received significant quantities of other waste types.

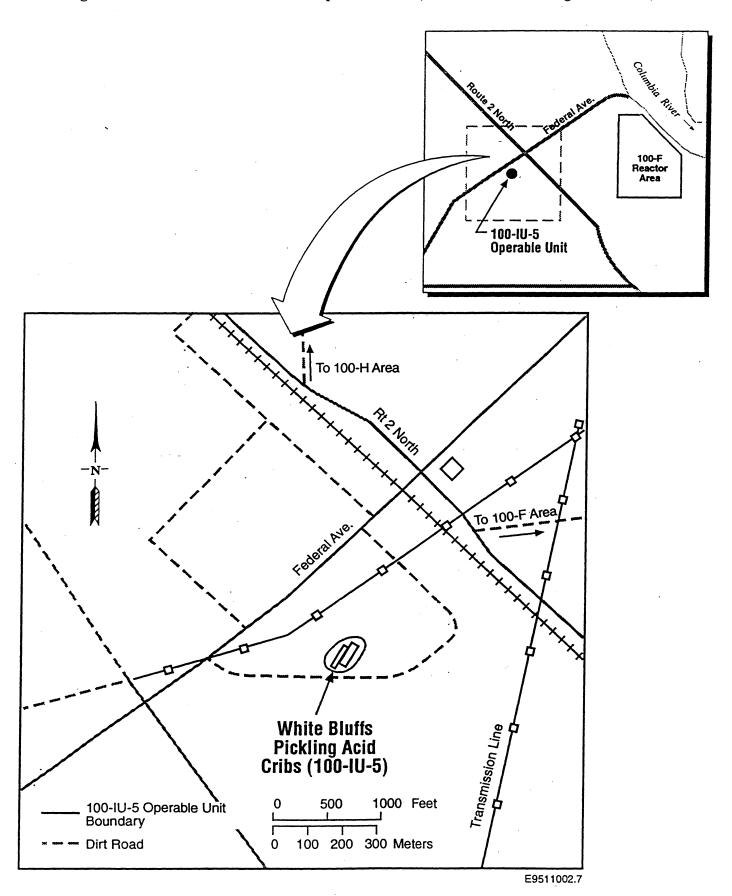
Figure 6. Location of the 100-IU-5 Operable Unit (White Bluffs Pickling Acid Cribs).

The White Bluffs Pickling Acid Cribs Site (Figure 6) is the only site identified in the 100-IU-5 Operable Unit. The White Bluffs Area was the location of construction activities from about 1943 to 1959. After termination of construction activities, the White Bluffs construction support facilities were torn down. Other than the historical information obtained in the *Hanford Site Waste Management Unit Reports*, little is known about activities conducted at the site. It is believed the cribs received waste streams (primarily nitric and hydrofluoric acid etch solutions) from a pipe fabrication facility operating sometime between 1943 and 1959. The pipe fabrication facility location is suspected to have been northeast of the cribs in 100-IU-2 Operable Unit (White Bluffs Landfills and JA Jones 2 Construction site).

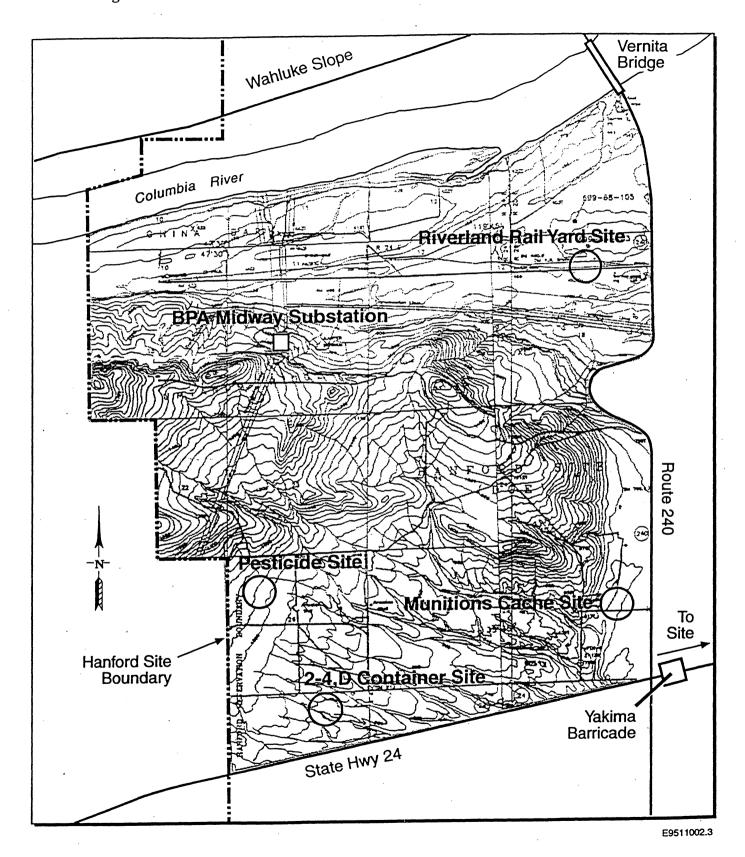
Figure 3. Location of Sites Within the 100-IU-1 Operable Unit (Riverland Site).

The Riverland Rail Yard (100-IU-1 Operable Unit, Figure 3) supported Hanford construction and operation activities from 1943 until 1954, while decontamination of radioactive rail cars continued until 1956. Included in this site are a 2,4-D pesticide container site, a rail yard maintenance facility, and two former military installations with associated demolition debris.
